TECHNICAL REPORT GL-85-5

THE VAIONT SLIDE, A GEOTECHNICAL ANALYSIS BASED ON NEW GEOLOGIC OBSERVATIONS OF THE FAILURE SURFACE

Volume II
APPENDICES A THROUGH G

A. J. Hendron, Jr., F. D. Patton

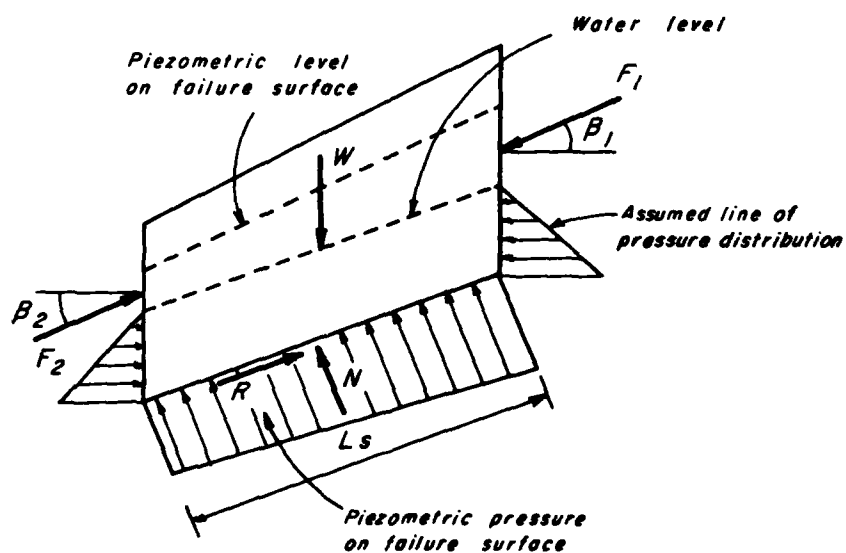
Figure B2. Forces on a typical slice of a slide

W = total weight of soil and water above the failure surface
 N = effective reaction normal to the failure surface
 R = shearing resistance of the soil
 F_1, F_2 = interelement forces between adjacent slices
 β_1, β_2 = inclination of the interelement forces from the normals to the slice faces.

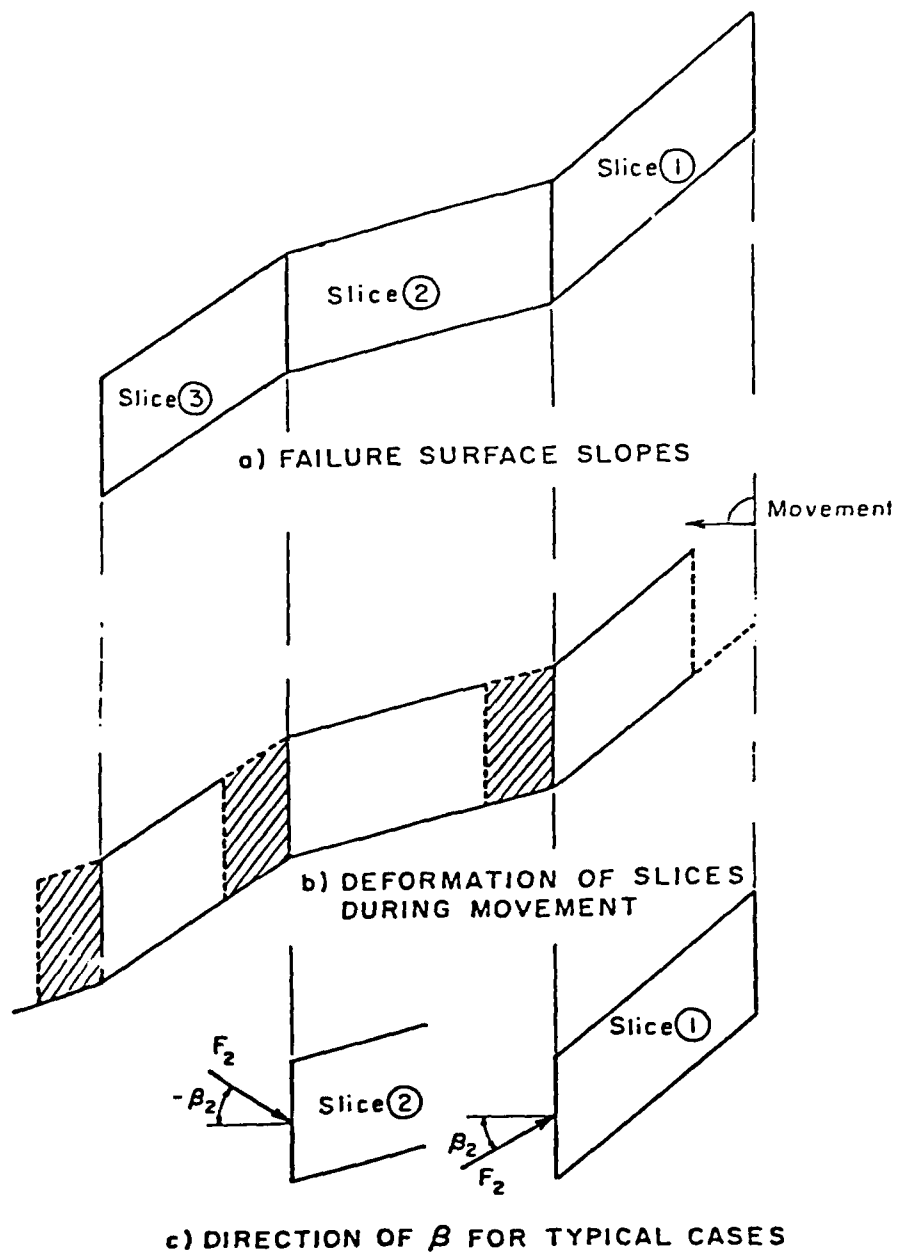
Figure B3. Illustration of method for assigning direction of frictional forces between slices

slices. If the failure surface of three slices is as shown in Figure B3a, and if the slide moves downhill, then the lower part of slice (1) must be deformed upward, as shown in Figure B3b, and so the inter-element force must provide an upward force on slice (1) as shown in Figure B3c. Thus, β_2 for slice (1) would be positive (assuming F_2 is positive). Following the same argument β_2 would be negative for slice (2). Assigning these directions and performing the static analysis as previously described, gives the same results as accounting for the work done in deforming the slide as it moves over changes in the slope of the failure surface. The latter is similar to the upper-bound limit analysis of plasticity theory.

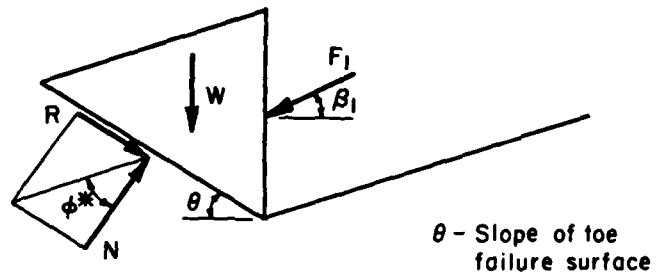
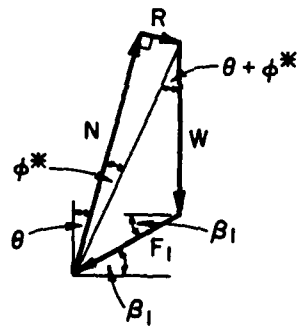
a) Forces on toe wedge

$\phi^* = \phi$ required for equilibrium

b) Vector Diagram of toe forces

If the toe has a sharply upturning failure surface, it may possibly form a toe wedge that theoretically makes the overall slide very stable, sometimes leading to an infinite value of the computed factor of safety, which is independent of the stability of the material above the toe wedge. In reality this would not occur as the toe would tend to fail along a different failure surface that did not provide this wedging

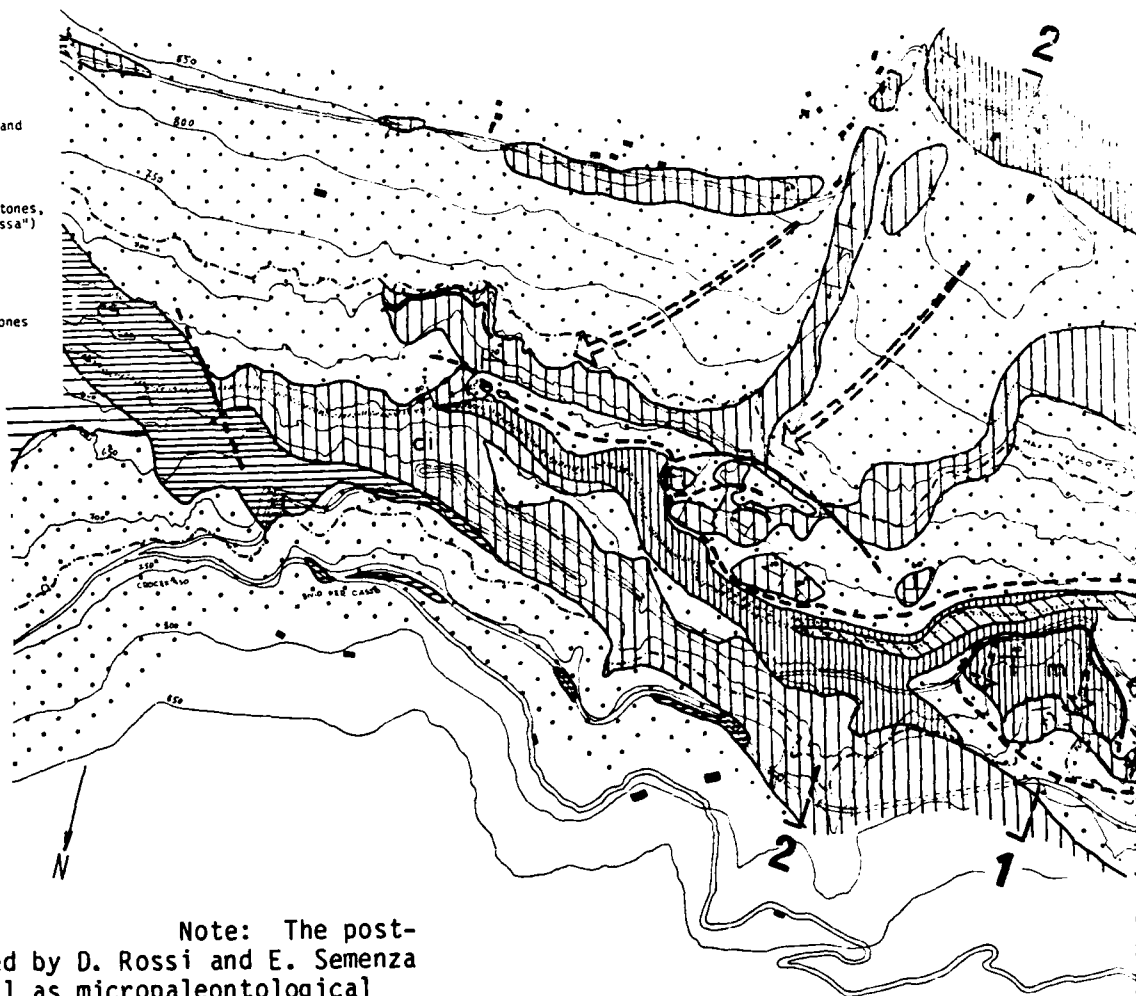
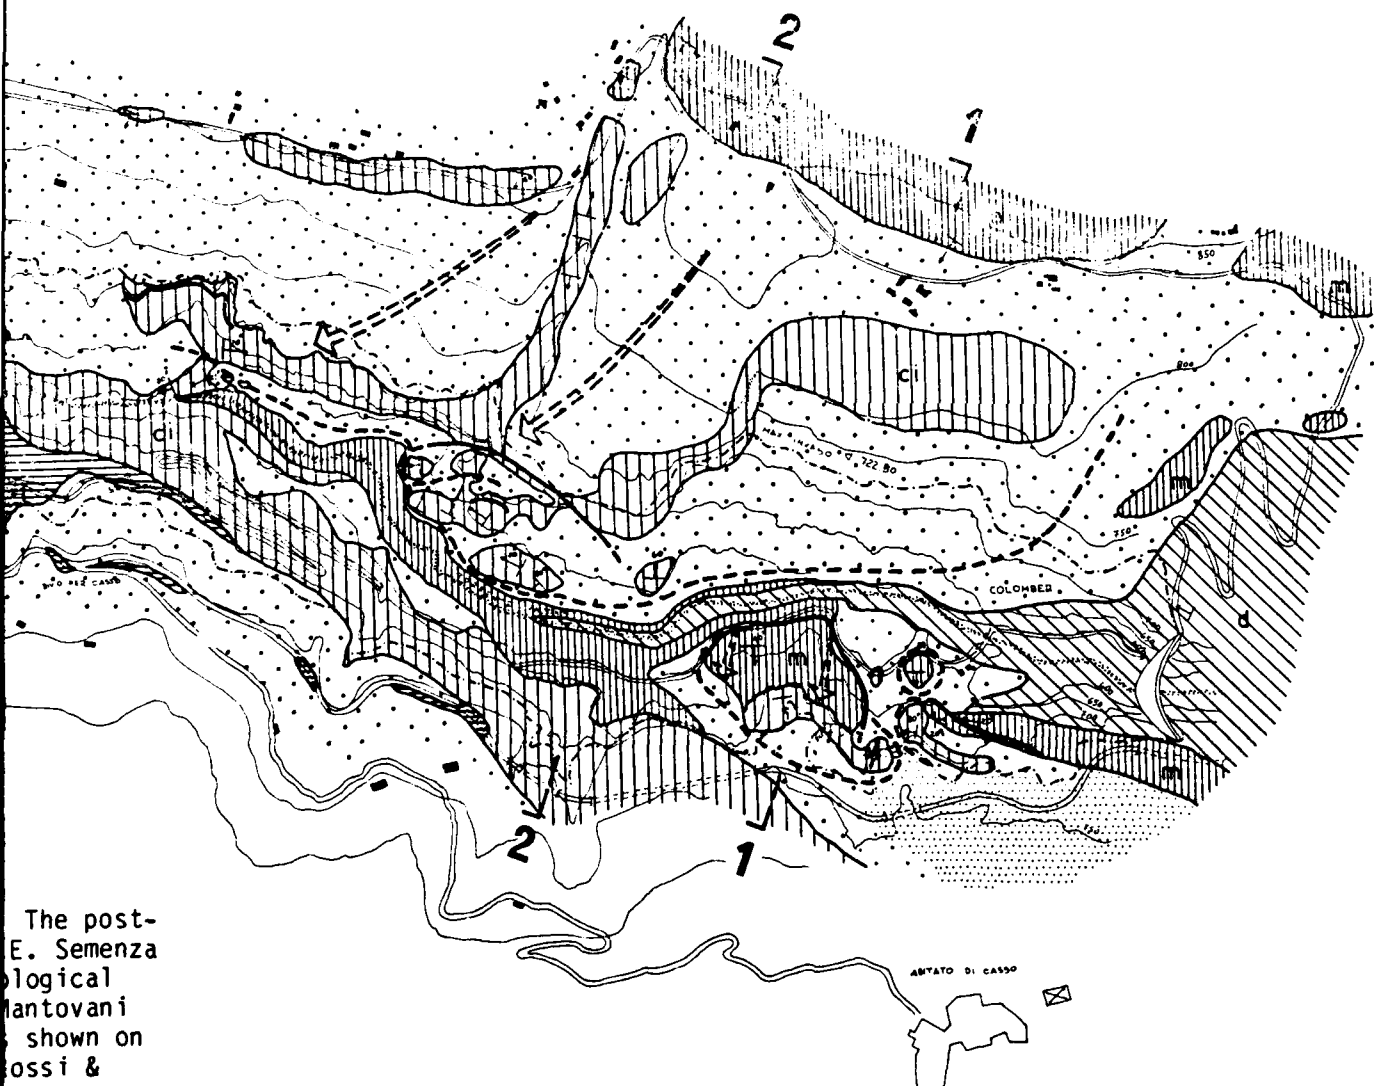
Figure G2. Geological map of the "Pian del Toc" zone taken from the "Geological Study of the Vaiont Reservoir" by F. Giudici and E. Semenza, 1960.

Note: The post-slide studies conducted by D. Rossi and E. Semenza (1963 to 1965), as well as micropaleontological studies by C. Broglio Loriga and M. G. Mantovani (1961 to 1965) proved that some outcrops shown on this map are erroneously dated (see D. Rossi & E. Semenza, 1965).

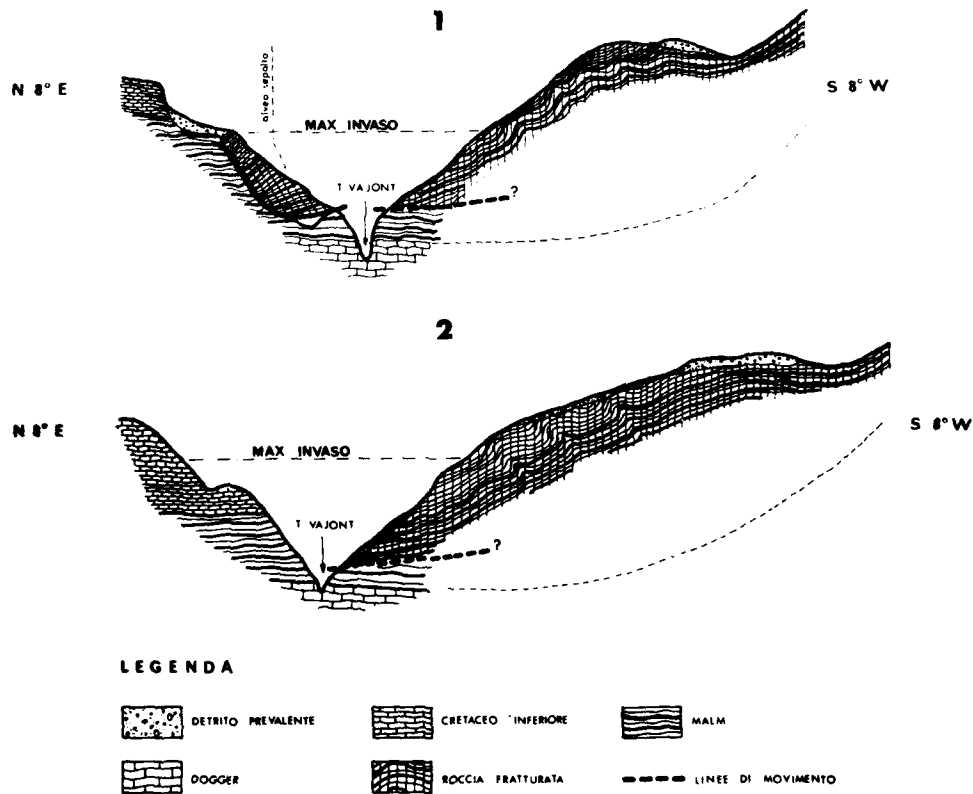
Figure G3. Geological profiles of the "Pian del Toc" zone, taken from the Geological Study of the Vaiont Reservoir" by F. Giudici and E. Semenza, 1960. (See note, Fig. G2)

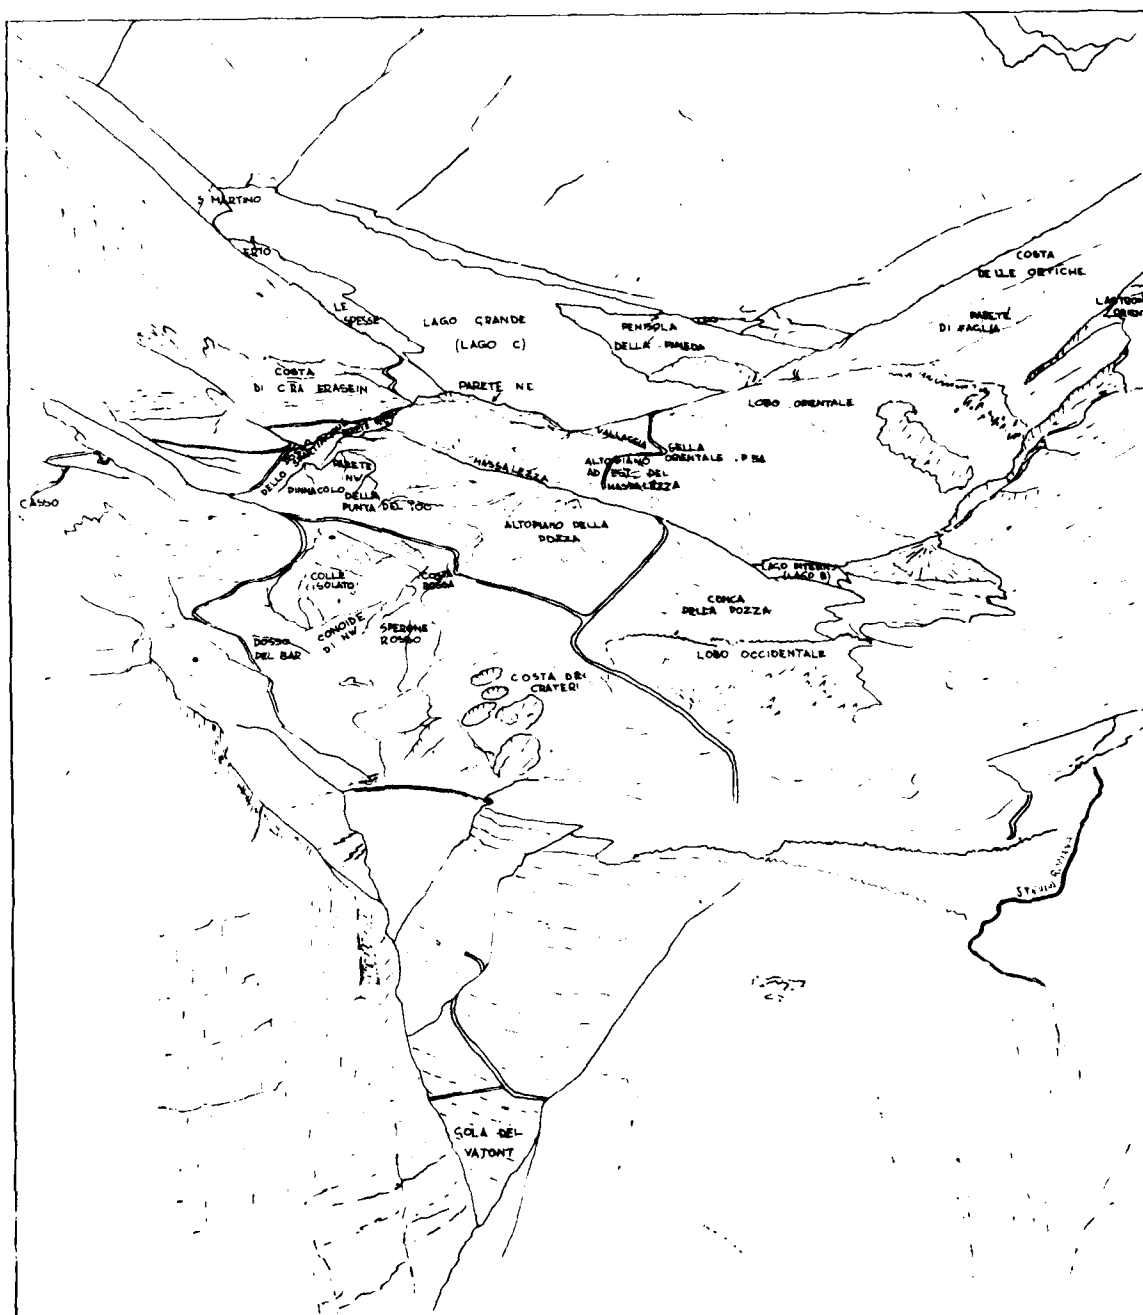
Figure GI4A - March, 1964. Fig. GI4A is an aerial view of the slide mass. The sketch shown in Fig. GI4B shows all the location names used in the text.
